MPS GH2 Flow Control Valve Poppet Failure Investigation Summary

Space Shuttle Main Propulsion System Gaseous Hydrogen Flow Control Valve Poppet Failure

Presenter: Rick Zeitler
United Space Alliance
Subsystem Area Manager APU/HYD/MPS
321 861 3123

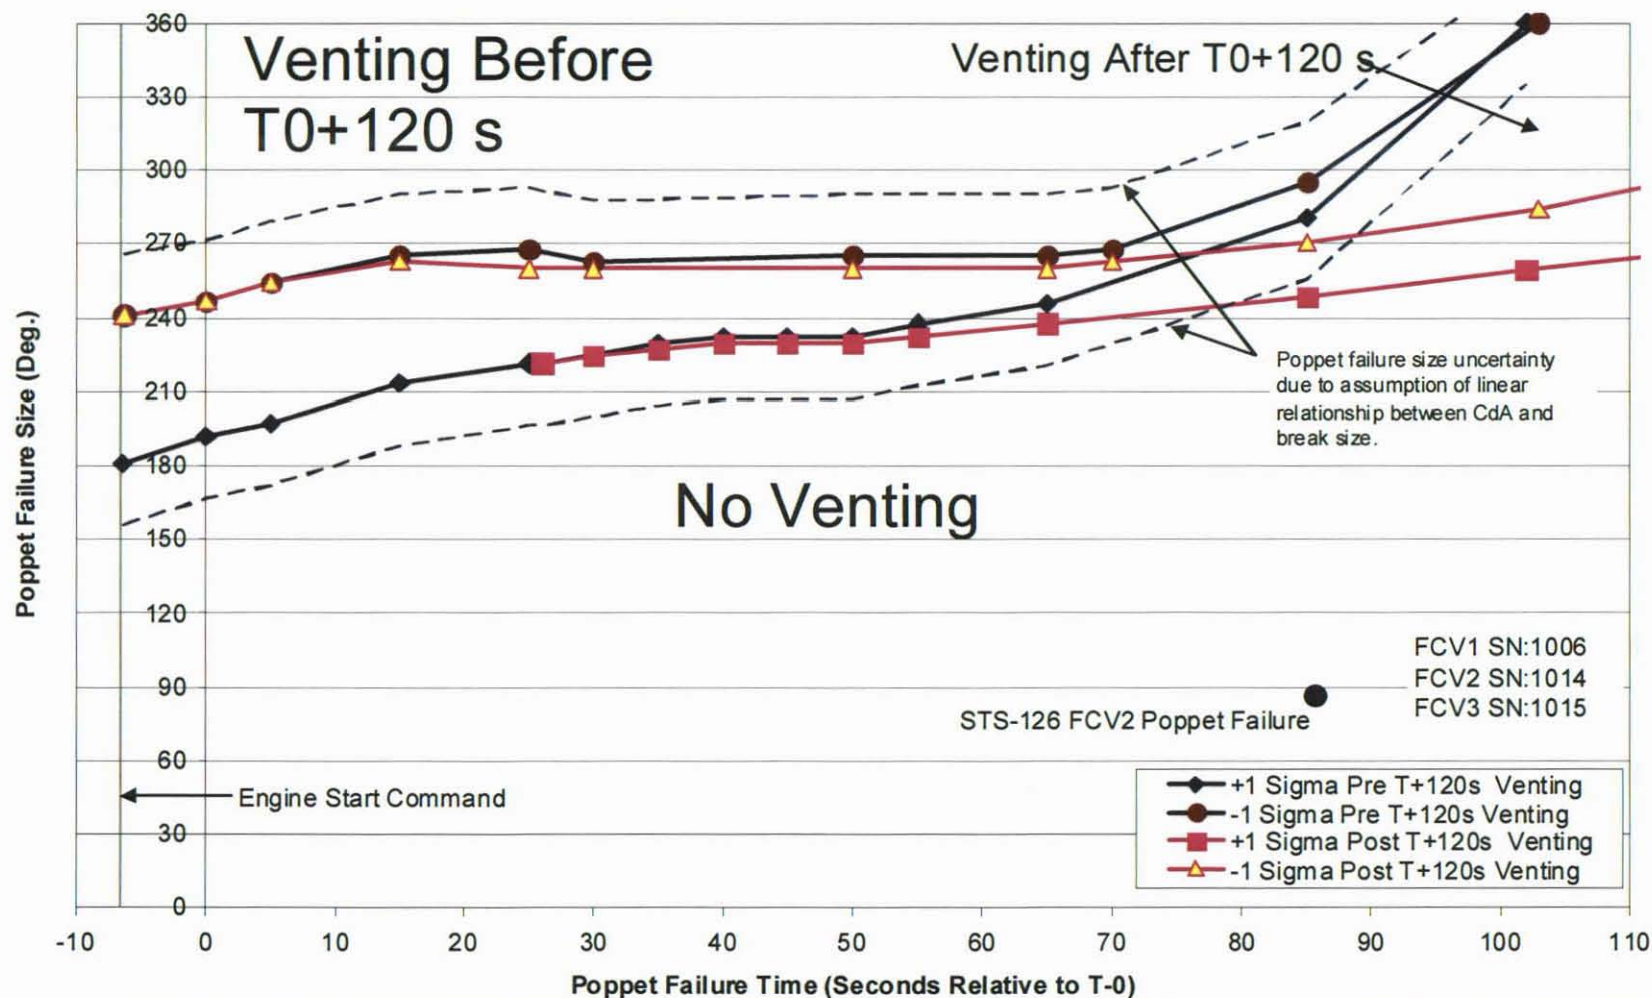
Figure 2.

- Integration team analyzed relationship between the size of poppet crack & effects on ET venting
 - Both single & two poppet failure cases included in venting analysis
 - Analysis constructed with STS-119 data – includes SSME specific operating performance parameters
 - Accounts for $\pm 1 \sigma$ dispersions
- For single poppet failure, no risk of ET venting for poppet particle sizes up to 125 degrees (see Figure 2.)
 - STS-126 poppet failure ~90 degrees
 - Bounding fracture analysis indicates the worst case poppet liberation size to be ~125 degrees
- For two poppet failures, low risk of ET venting (see Figure 3.)
 - Case 1. - two poppets of STS-126 size (~90 degrees) must fail between SSME start (T-6 seconds) to T+2 seconds
 - Case 2. - for poppet failures 1.25 x STS-126 size (~115 degrees), two poppets must fail between T-6 seconds & T+55 seconds

Exposure Windows for a Single Poppet Failure Causing H2 Venting
